UAS Case Studies

New Hampshire Department of Transportation

Unmanned Aircraft Systems (UAS) are a new capability that has the potential to reduce costs dramatically and increase safety for transportation operations. Despite the considerable amount of existing research and case studies surrounding UAS, there appear to be few, if any, that have focused on analyzing the costs, benefits, and barriers associated with integrating UAS into a state department of transportation's operations. The overall objective of this project focused on evaluating UAS technology for a broad range of case studies relating to the specific needs of the New Hampshire Department of Transportation (NH DOT). This project was a partnership between NH DOT and the University of Vermont's (UVM) UAS Team. UVM's UAS Team conducted flight operations and generated products for eight case studies. These case studies served the purpose of evaluating the applicability of UAS for NH DOT, comparing UAS to existing methods and analyzing the barrier to UAS implementation.

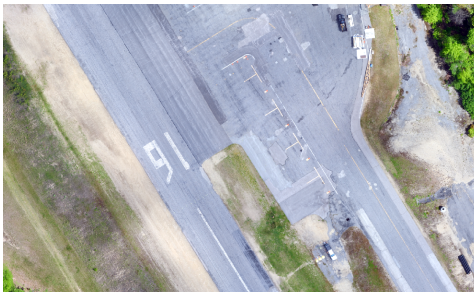
ORTHO MOSAIC

Overhead imagery, orthorectified, 3-band, true color, 1.2 in pixel size, horizontal accuracy up to +/- 1cm (hard ground surfaces), GIS/CAD ready

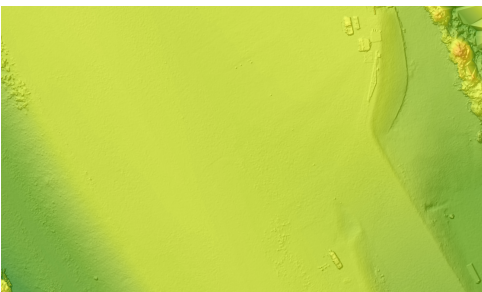
DIGITAL ELEVATION MODEL

Photogrammetrically derived raster elevation model generated from the point cloud, resolution as good as 5cm, GIS/CAD ready. The above image is same extent of the imagery, but displaying the DEM.

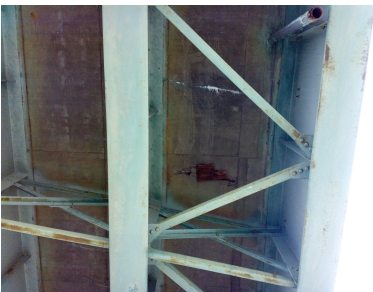
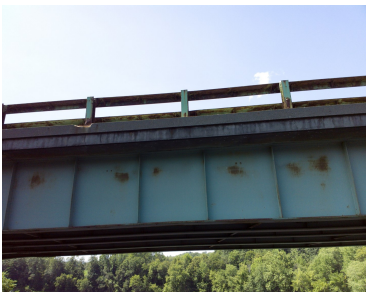
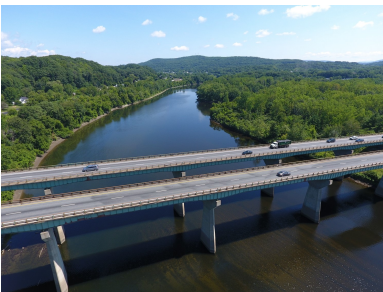
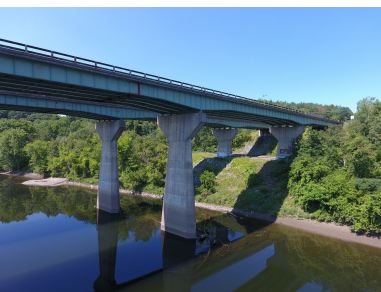
INSPECTION PHOTOS

High resolution inspection photos in true color and thermal photos. Ability to acquire photos of hard to reach and awkward angles.

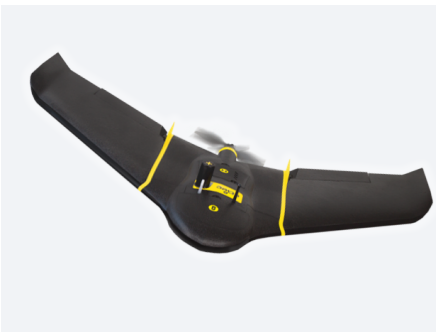
Evaluated the application of UAS for inspecting construction

A fixed wing UAS called the senseFly eBee Plus was flown to collect images to create derived geospatial datasets.

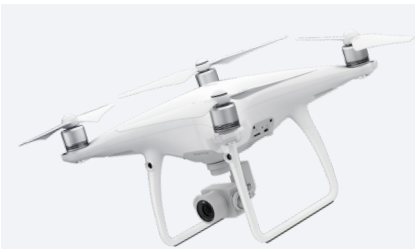
The DJI Phantom 4 is a quad-copter platform with a high performance camera that can shoot video in 4K at 30 frames per second. The UAS team had four batteries for the DJI Phantom with each battery capable of a ~25 minute flight. This project took 2 UAS flights to acquire the necessary data. It takes under five minutes to set up the drone for each flight.
